ZUMMO

Z14

MANUAL TÉCNICO
TECHNICAL MANUAL

Z14 TECHNICAL INSTRUCTIONS

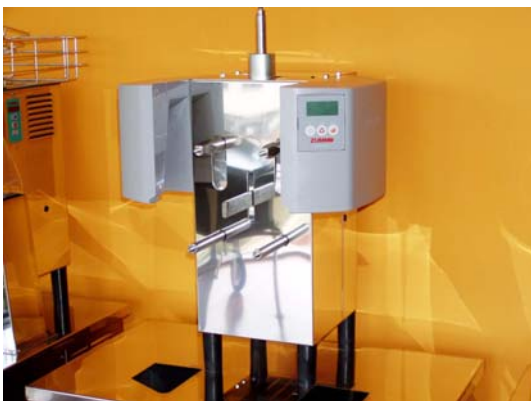
1

Remove all the external parts (Fig. 1)

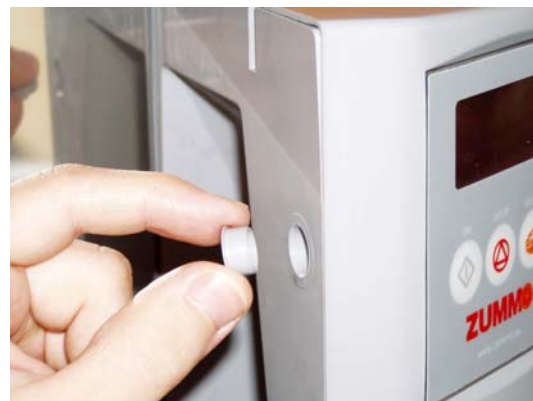
2

Extract the right-hand side plate top plug. (Fig. 2)

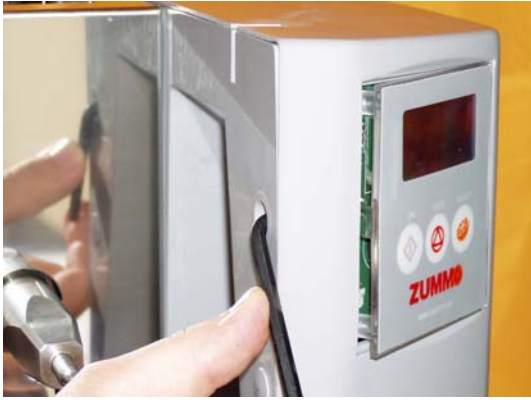
3

Extract the electronic circuit board by pressing with the short end of a No.5 Allen key on the circuit board tab. (Fig. 3)

N.B. Insert the short end of the key (Fig. 3), do not use punches or screwdrivers as these may damage the electronic circuit board.

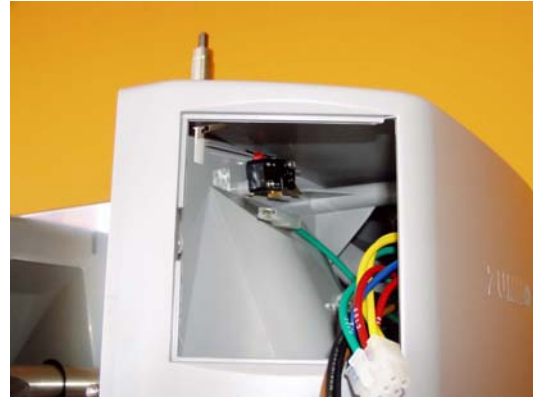
4

Remove the board completely from the machine.
Disconnect the wires from the short micrometer. (Fig. 4)
Extract the wiring from inside the side plate.
Extract the front of the machine.

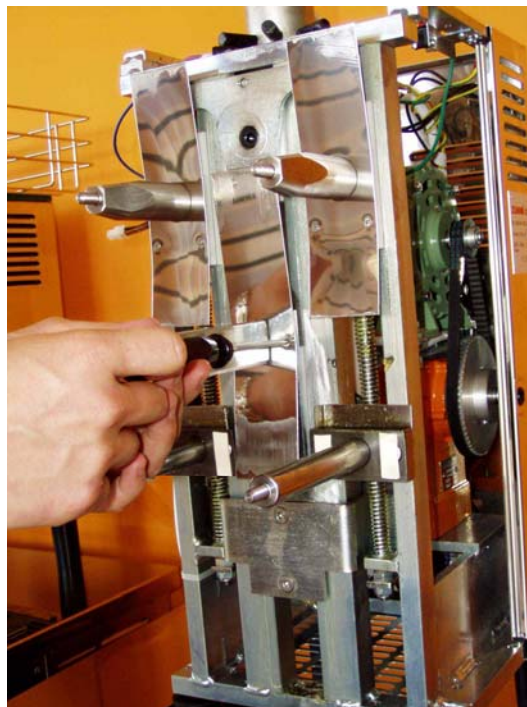
5

Extract the three runner covers (to be able to work safely). (Fig. 5)

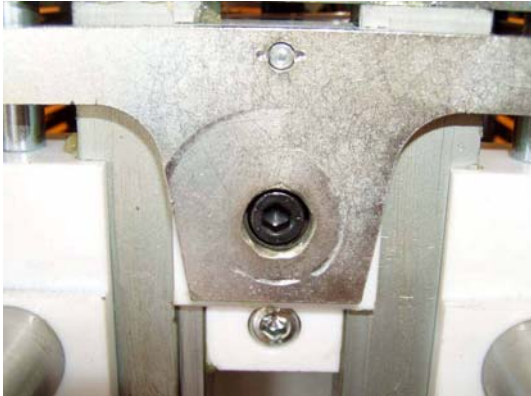
6

Extract the top bolt from the bridge. (Fig. 6)

Extract the pusher assembly. (Fig. 6)

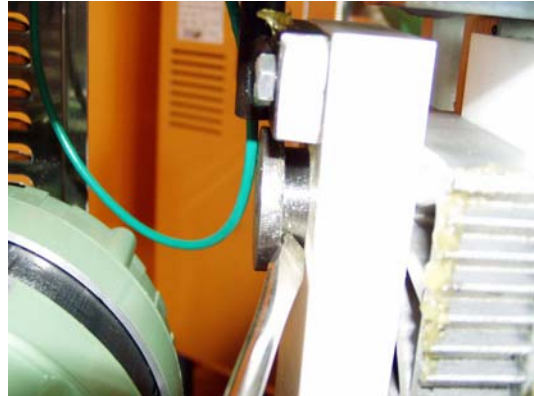
7

Extract the top pin

with the aid of a screwdriver. (Fig. 7)

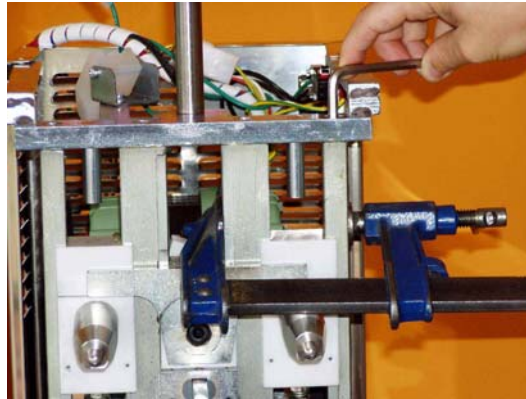
- In the event of there being play (greater than 0.2mm) between the cup

runner and the bars guiding it, this play needs to be reduced. To do so, loosen the top chassis bolt corresponding to the outer bar of this runner, lower the runners as in Photo 8 and retighten the bolt but with the bar held closed with the aid of a clamp. You should then check that it has not been closed too much. The runner should rise and fall smoothly without catching.

- If the runner play is incorrect, a set of cogs with special (oversized) teeth needs to be ordered from the manufacturer.

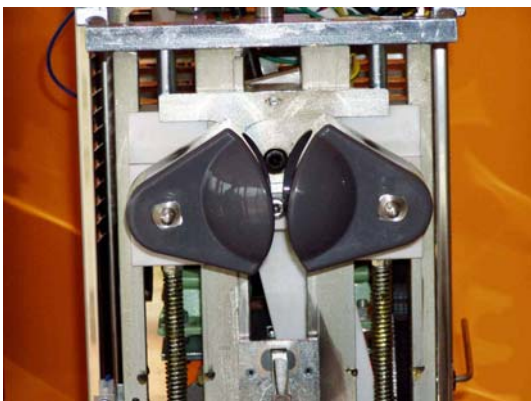
9

With the cups vertical, and the bridge at its highest point, lift the divider locking

tab and turn the cups in reverse direction (turn the reducer pulley in a clockwise direction) until the cups are facing each other. (Fig. 9)

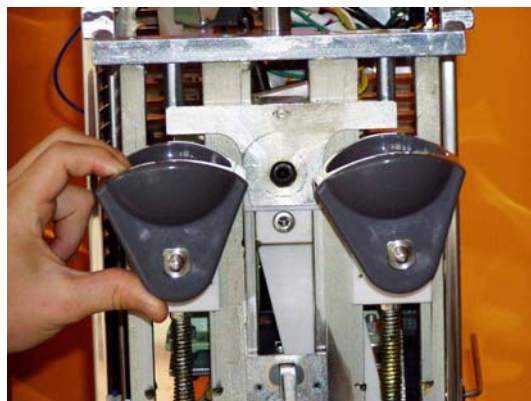
10

Raise the cups by hand to the vertical position and release them (Fig.10). The cups should rise and fall freely without any stiffness of movement. If they move stiffly, the guides should be cleaned and greased.

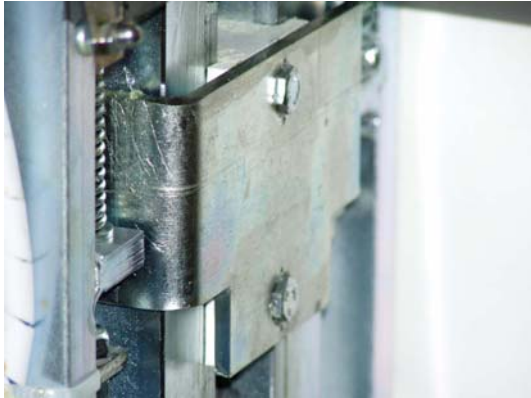
11

These bolts were originally of a “countersunk Allen” type and did not allow adequate tightening. They were factory fitted from machine No. 2067126 onwards. If this is the case, they should be changed for hexagonal head bolts (Fig. 11). The top bolt is M6x16 and the bottom one M6x30. The adjustment of the lower bearing pin should also be checked. This is done as follows:

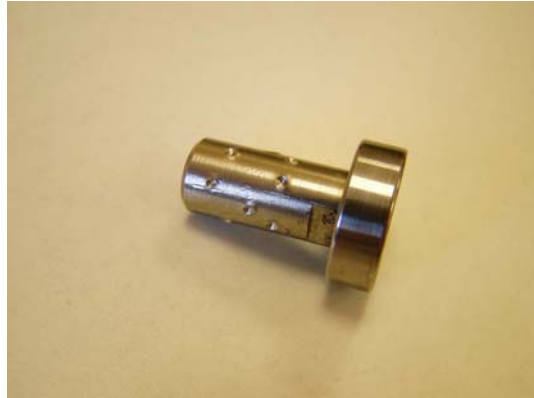
12

If play is detected, extract it and use a punch to produce protuberances (Fig. 12) in order to eliminate this play.

THE HEAD OF THE PIN MUST NOT SIT IN THE RUNNER HOLE, EVEN WITHOUT A SECURING BOLT

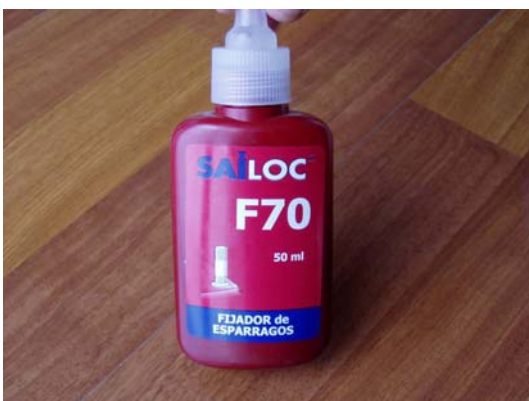
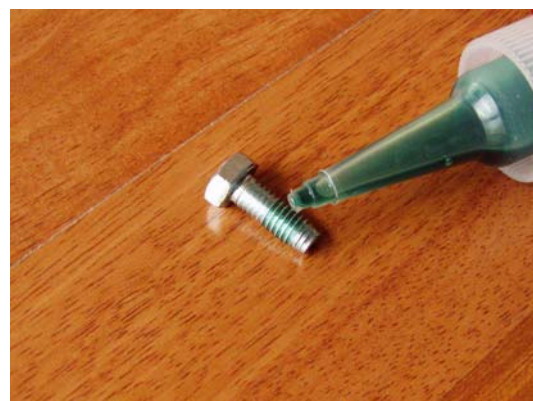
Apply thread-locking adhesive to the bolt threads (Fig. 13 and 14) and fit them.

TAKE CARE WHEN TIGHTENING THE TOP BOLT, AS IT IS THREADED DIRECTLY ONTO PLASTIC AND COULD PASS THROUGH IT

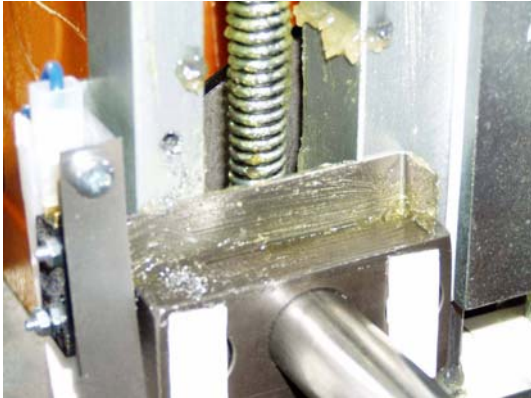
The machines were not originally fitted with these parts, which were incorporated from No. 2116011 onwards.

These parts (reference Nos. 1405017 and 1405018) are to prevent the juice entering through the cup runner covers from reaching the central guides.

If your machine does not have these parts, they should be fitted. It is simply a question of fitting them as in Photo 15 and greasing the joints to prevent the juice from leaking through the slots.

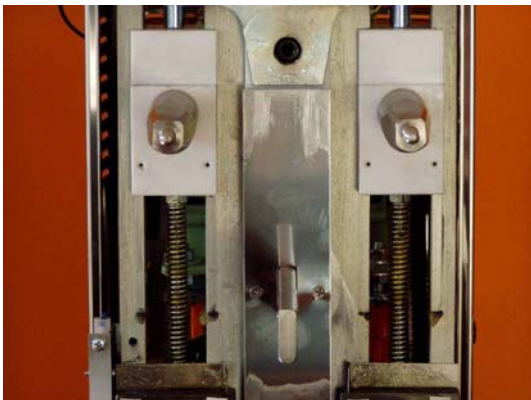
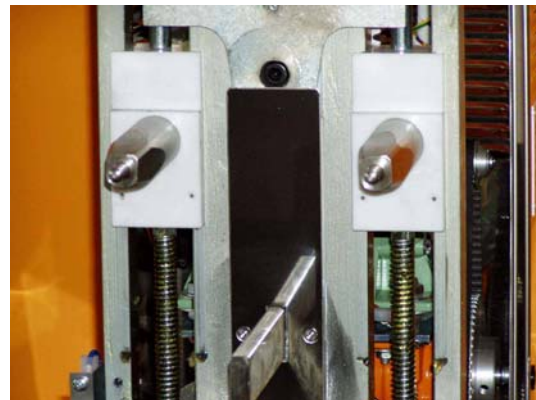
This part originally measured 214mm (Fig. 16) and was later lengthened to 230mm (Fig. 17). This change was made from machine No. 2077001 onwards, and the new one can be distinguished by its rounded edges. (Fig.17)

If your machine is fitted with the short one, it should be replaced with the new model. The three runner covers have to be bent slightly forwards by around 20mm (Figure 18), and at the front, grease should be added in the area where they rub (Figure 19).

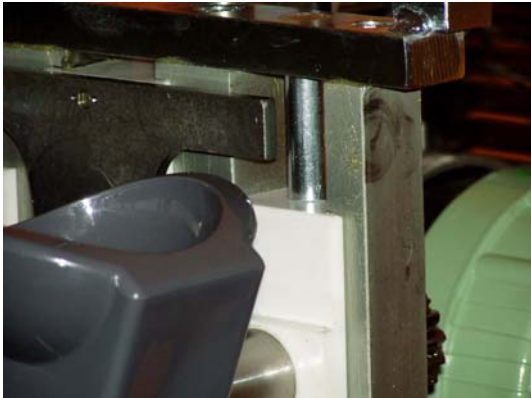
20

Move the cups to the vertical position. The runners should be touching the top end stops. (Fig. 20)

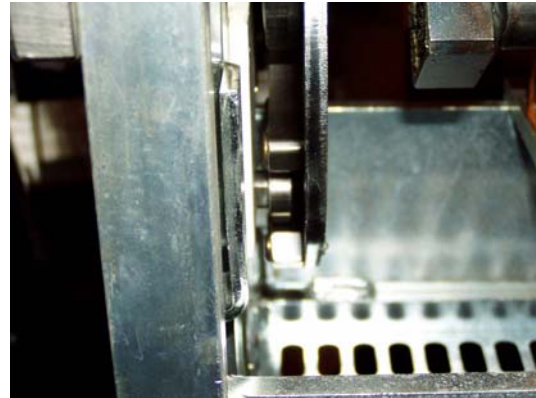
21

Turn the reducer pulley anticlockwise and observe how the sectors of the copier

move towards the bottom bearing. (Fig. 21)

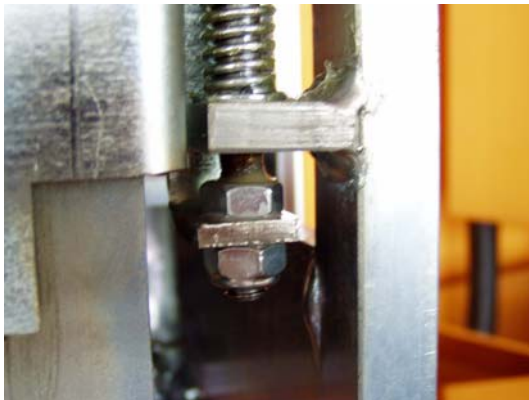
22

The bearing needs to be raised or lowered by adjusting the bottom nuts on the pullers (Fig. 22), so that the bearing enters the copier barely touching it.

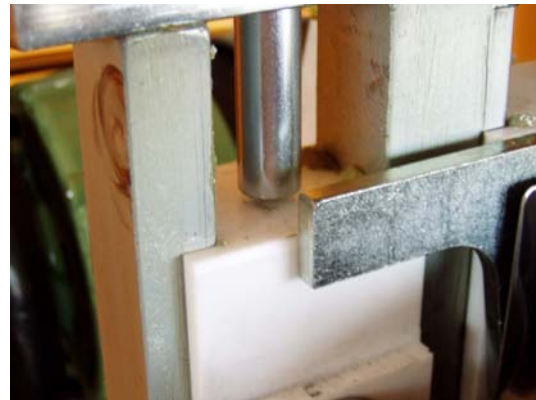
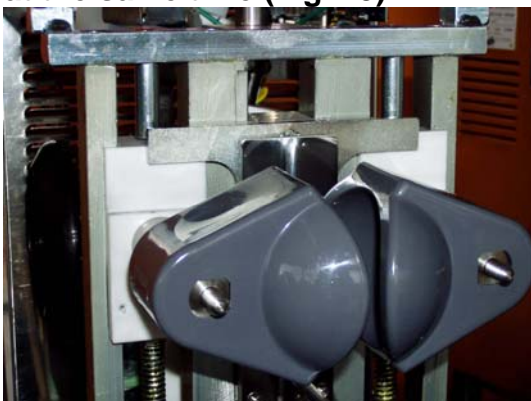
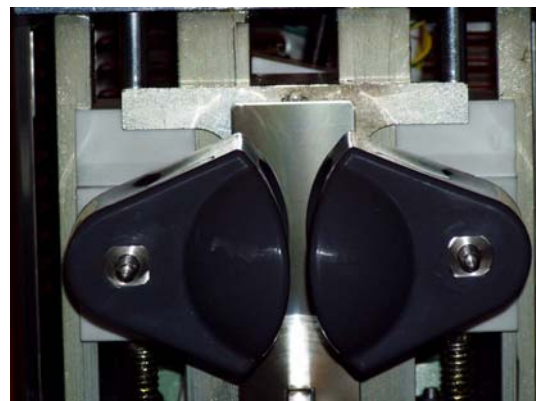
Keep turning the reducer pulley, and at the point where the cups stop turning and begin their descent, **they should be facing each other (Fig. 24 and 25), at the same level, and the runners should come away from the end stops at the same time (Fig. 23)**

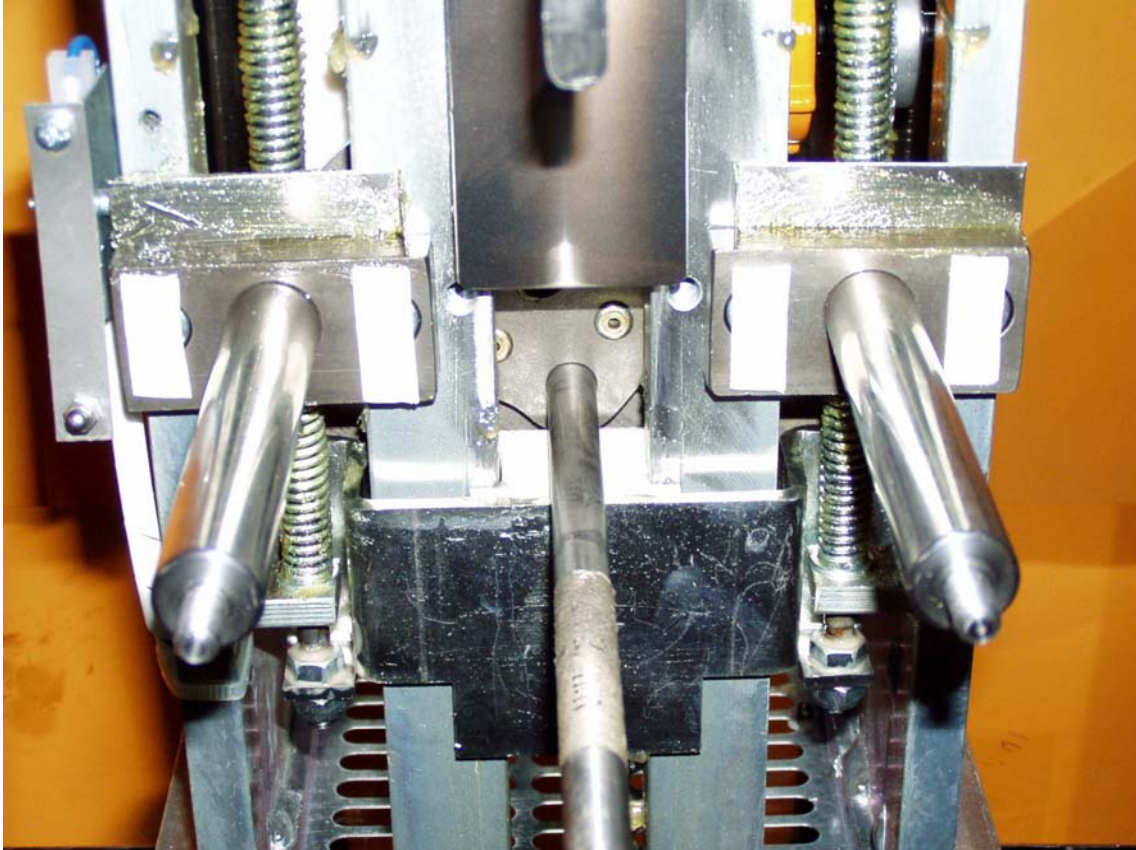
26

In these three cases the reducer needs to be released from its position, however, the most important point is that when refitting the reducer, the center of the reducer must be aligned perfectly with the center of the chassis. To do so, use a 12Ø rod inserted into the reducer shaft. This should be centered between the two central bars of the chassis. (a 12Ø drill bit can be used) (Fig. 26)

IT IS IMPOSSIBLE TO POSITION THE CUPS UNLESS THE REDUCER IS PROPERLY CENTERED

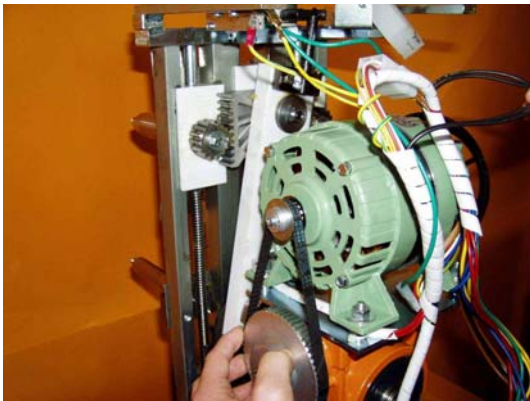
27

Raise the rod

to its highest point and position it completely vertically. To do so, turn the reducer pulley until this is achieved. (Fig. 27)

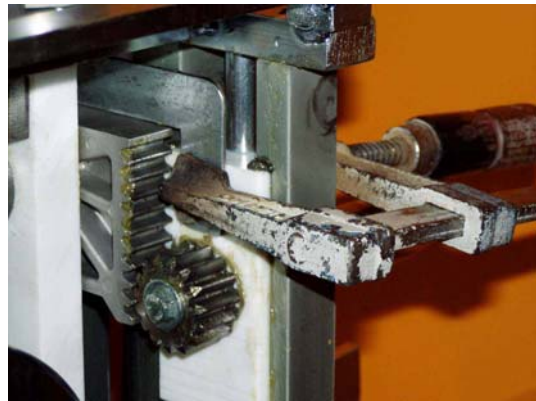
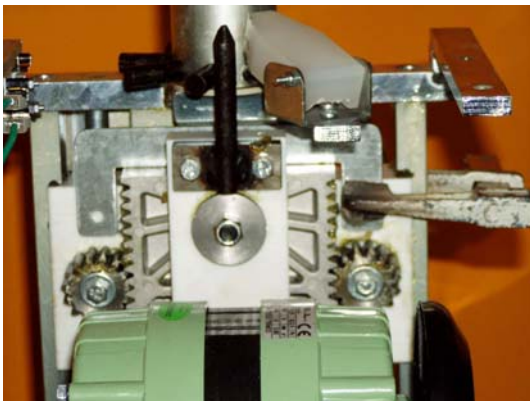
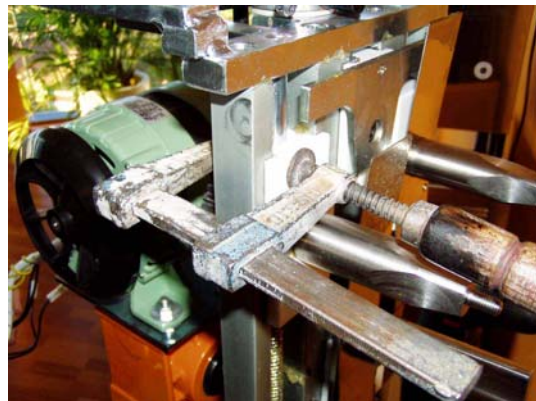
Once the rod is at its highest position, fit the new part. This should rest on the bridge and be centered, and held in place using a clamp (Figs. 28, 29, 30) to

ensure that it does not move during drilling. To do so, a cup runner cover

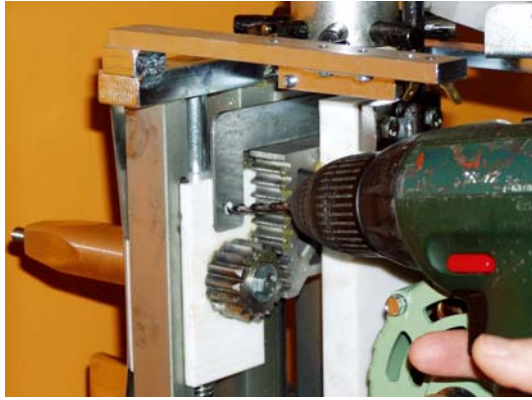
31

Drill 4.75Ø holes to a depth of 25mm. (Fig. 31)

The motor will prevent the holes from being drilled completely horizontally, however this is not important.

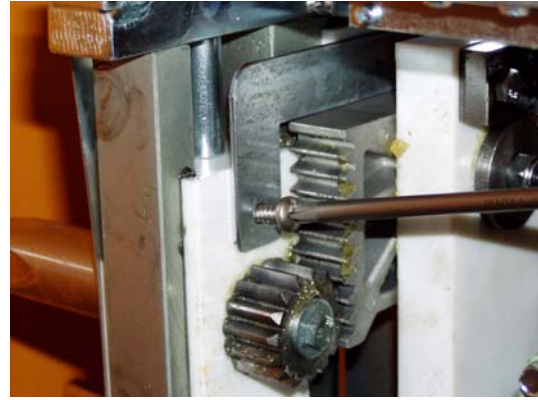
32

Fit the screws (Fig. 32). They must not be over-tightened.

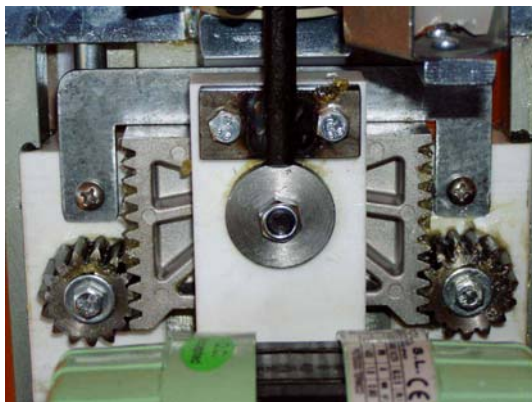
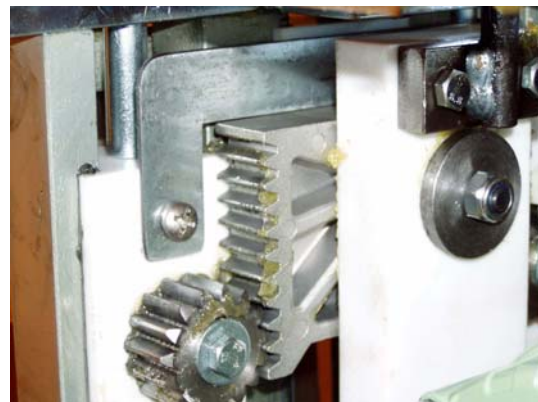
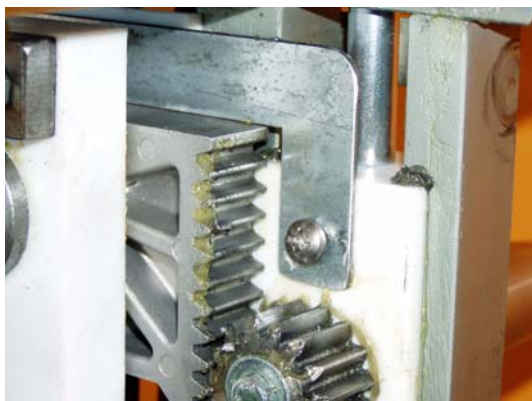
See the final result, Photos 33, 34 and 35.

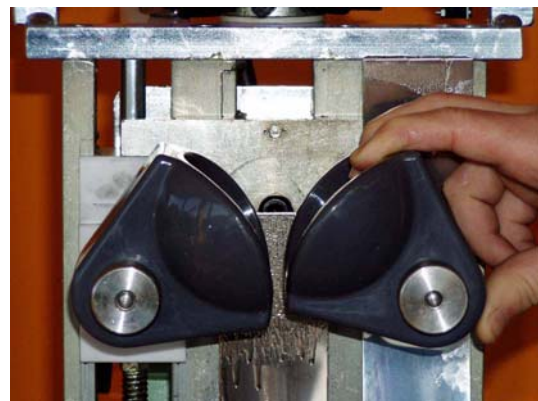
36

To check proper functioning:
Turn the reducer pulley clockwise until the cups are horizontal. Turn the cups by hand to the vertical position and release them (Fig. 36). On releasing them, the runners should reach the top end stop under the action of the springs, without manual assistance. Grease the runners and the springs if necessary.
